Memo

Project: Seismic Resilience Assessment

To: Brett Musick, PE, City of Newberg

Subject: Executive Summary

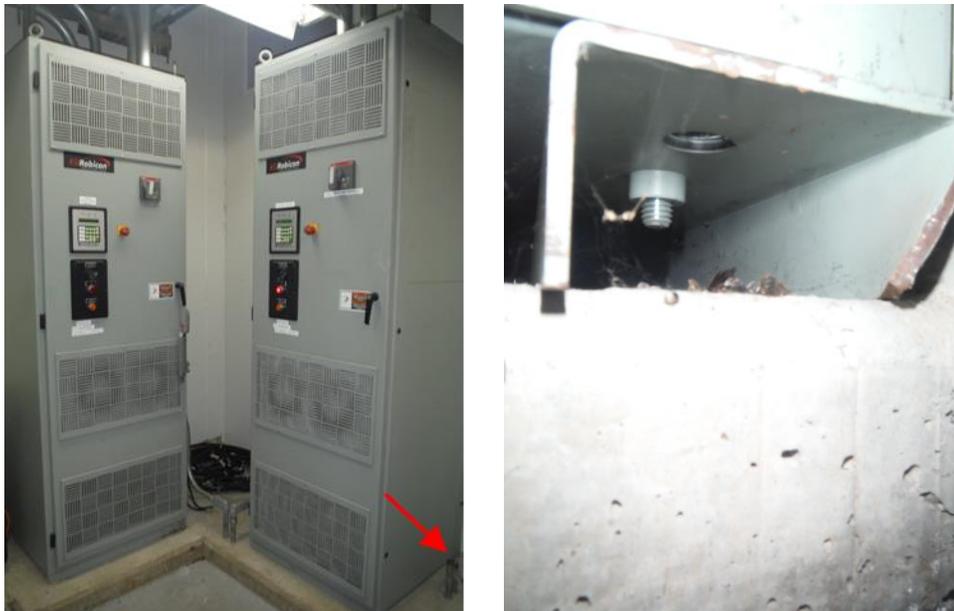
Figure 3.27 – Electrical Cabinets with Missing Anchor at the Base

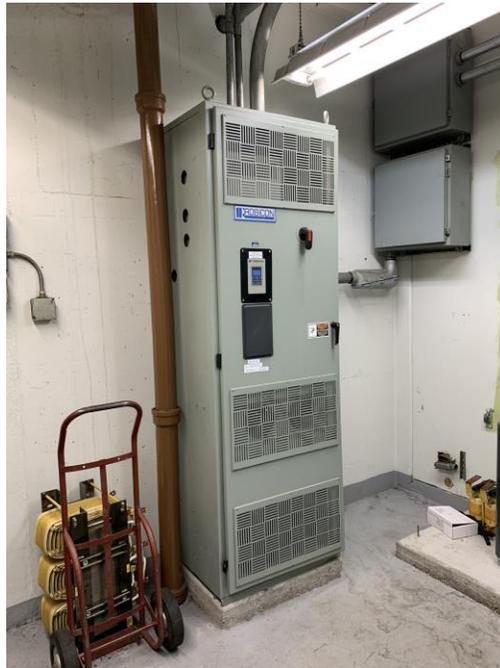
Figure 3.28 – Unbraced Cast Iron (Brittle) Vertical Pipe next to Electrical Cabinet

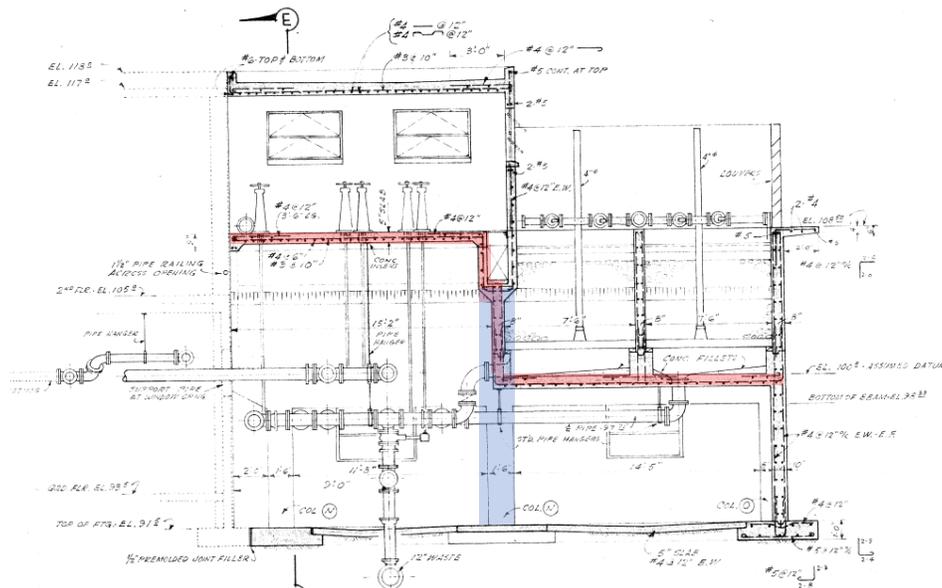
Figure 3.32 – Shear Wall not Continuous to Foundation (Blue Shaded) and with Split Level Diaphragms (Red Shaded)
(Source Drawings: “Water Treatment Plant Addition (A610001)”)

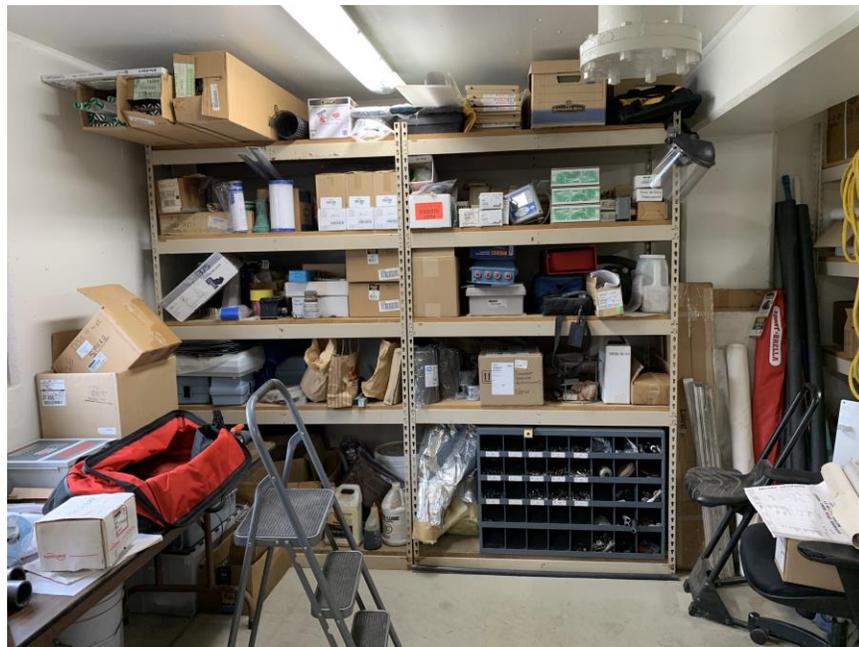
Figure 3.33 – Unrestrained Storage Rack

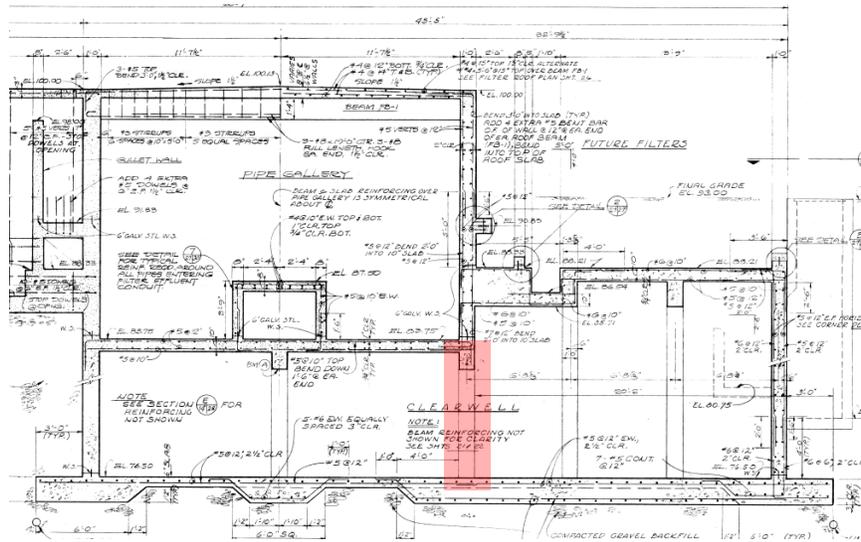
Figure 3.56 – Shear Wall not Continuous to Foundation
 (Source Drawings: “Water Treatment Plant (A700004)”)

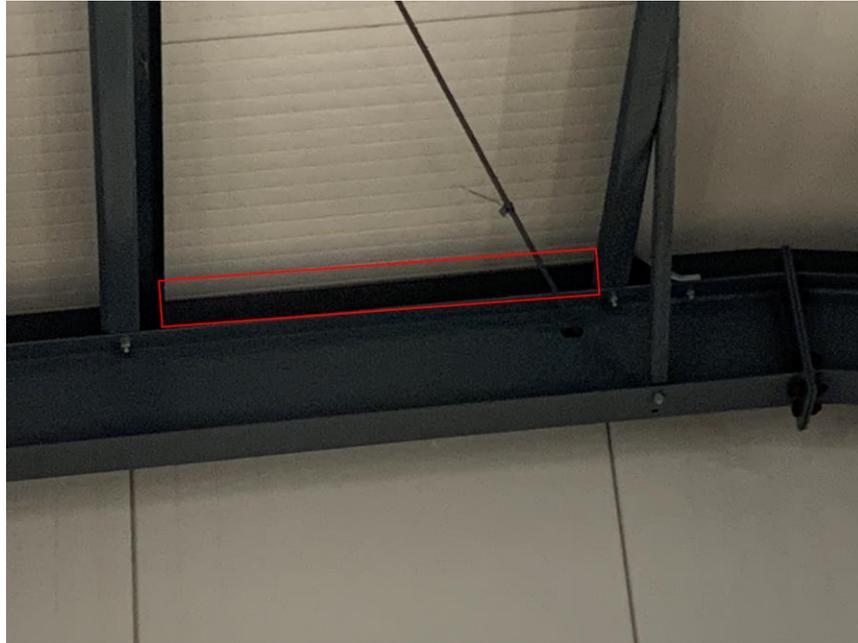
Figure 3.75 – Inadequate Load Path from Roof Diaphragm to Moment Frame Beams (no Blocking between Purlins)

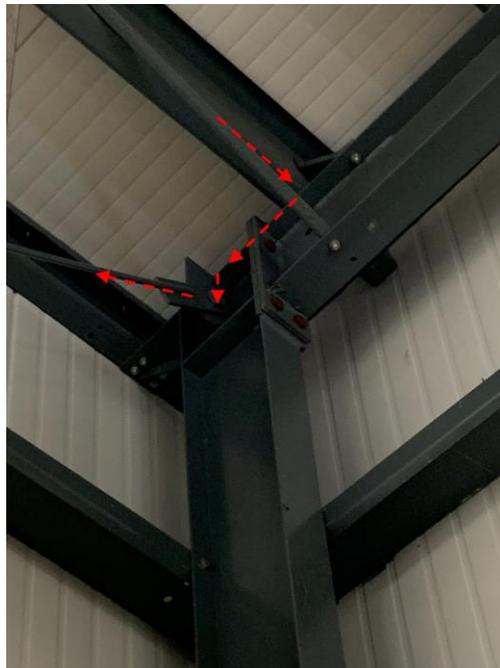
Figure 3.76 – Indirect Load Path from Diaphragm to Brace Frame

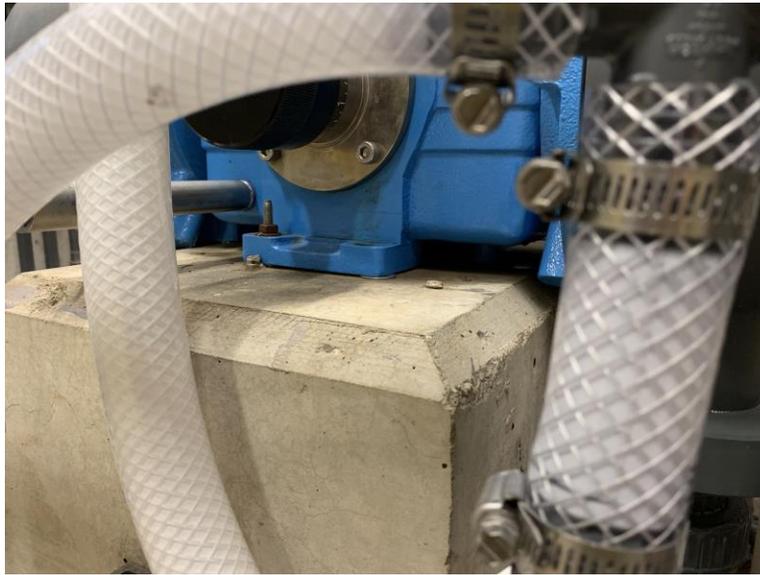
Figure 3.85 – Deficient Anchorage Between Chemical Feed Pumps and Concrete Support

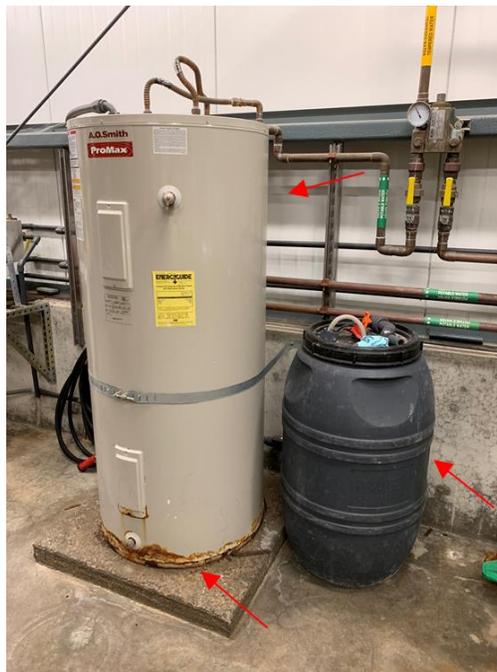
Figure 3.86 – Water Heater not Adequately Restrained and Unrestrained Barrel

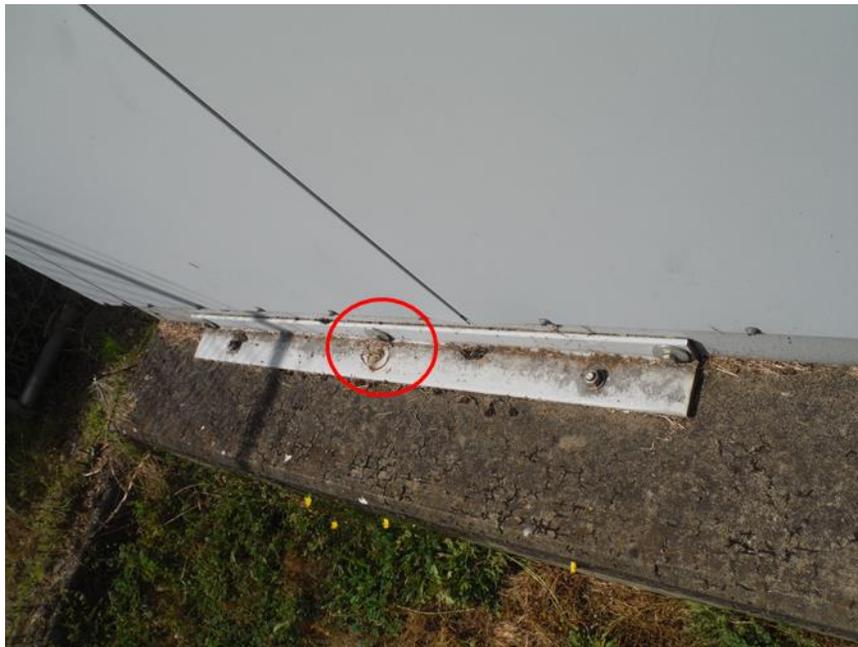
Figure 3.95 – Missing Anchors on Switchgear to Concrete Pad Connection

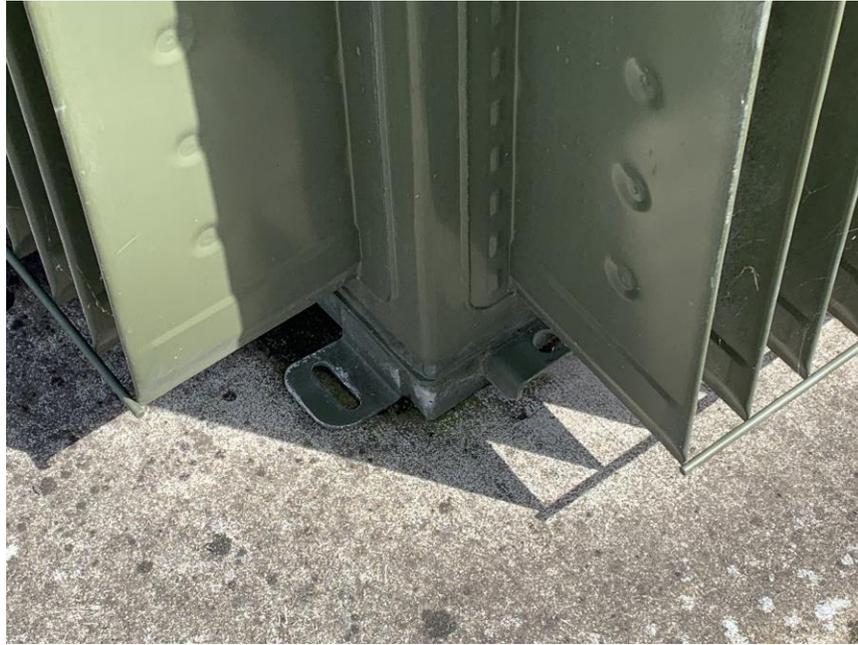
Figure 3.96 – Electrical Transformer not Anchored to Concrete Pad
